DuSable Park

**RIVER WALL CONDITION ASSESSMENT AND
PRELIMINARY REPAIR COST ESTIMATE FOR
PROPOSED DUSABLE PARK DEVELOPMENT**

UNDERWATER INVESTIGATION OF THE DUSABLE PARK DOCKWALL ALONG THE MAIN BRANCH OF THE CHICAGO RIVER IN CHICAGO, ILLINOIS

APRIL 2005

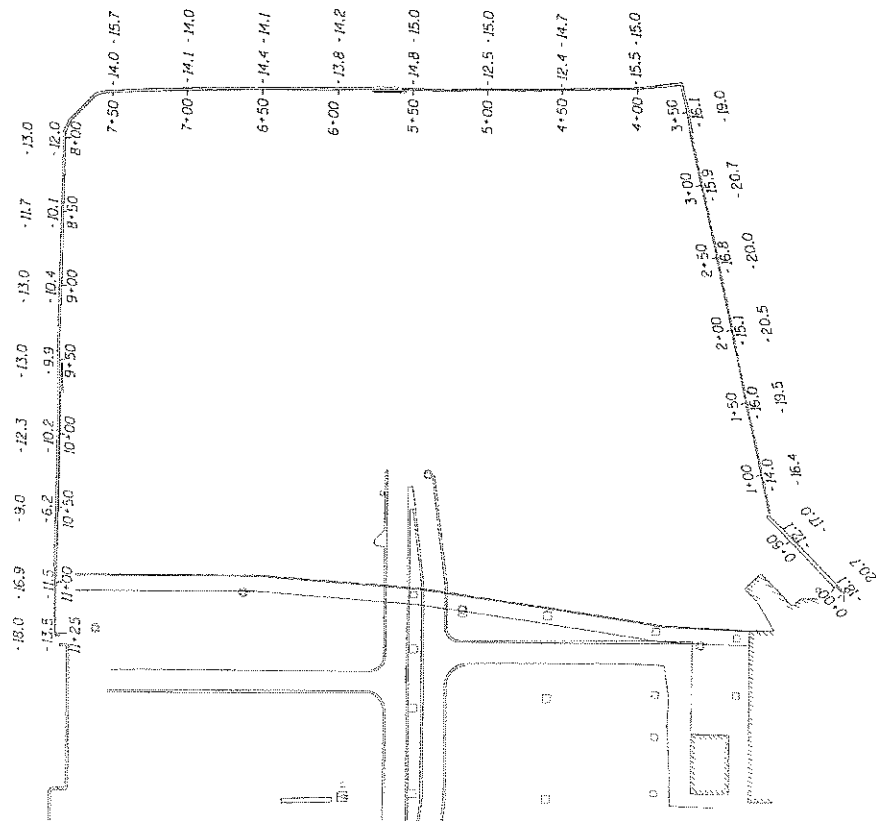
At the time of the inspection, the waterline of the Main Branch of the Chicago River was located approximately 7.0 feet below the top of the dockwall at Station 2 + 00. This corresponds to a waterline elevation of -2.07 feet Chicago City Datum (CCD), based on USGS data taken at Columbus Drive. Refer to Figure 2 in Appendix A for the dockwall configuration and sounding plan.

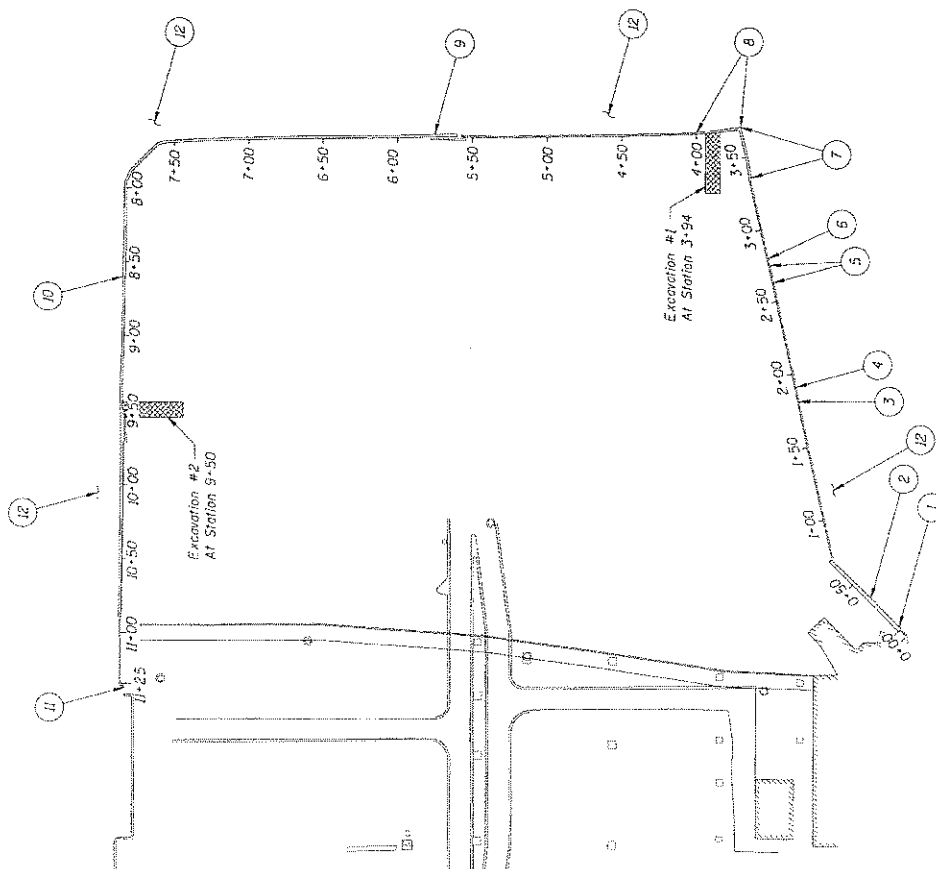
Around the perimeter of the dockwall, the channel bottom material typically consisted of silty sand and random interspersed construction debris, with up to 1.5 feet of probe rod penetration. Refer to Figures 3 and 4 in Appendix A for the Dockwall Plan and Inspection Notes.

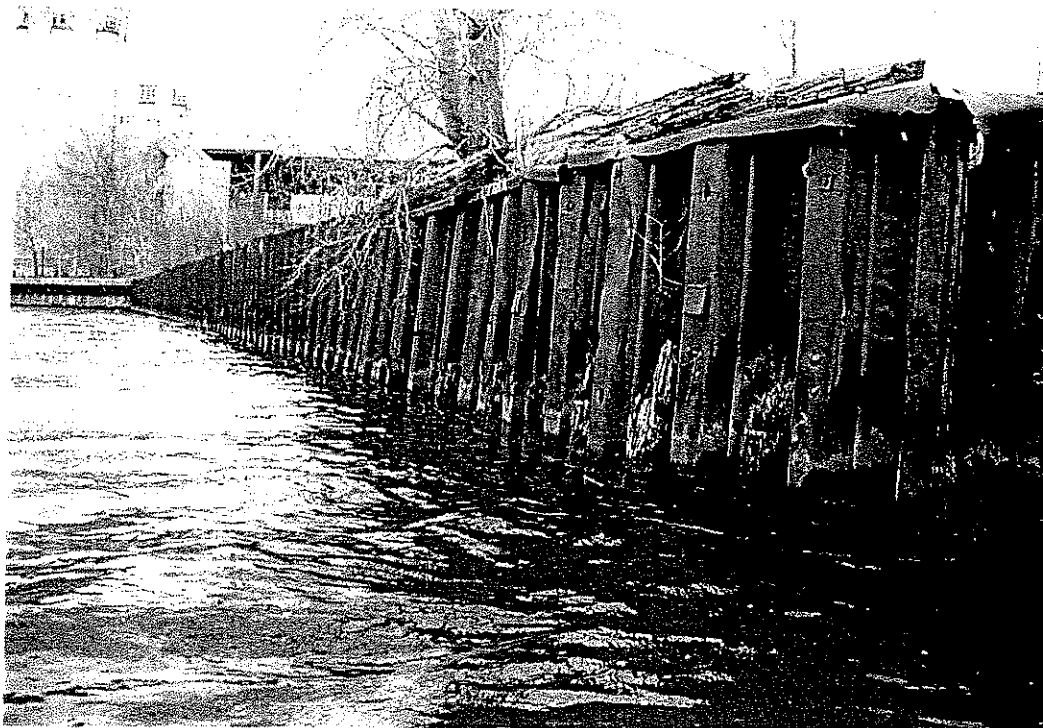
Photograph 1. Overall View of South Dockwall Face, Looking Northwest from Station 3+66.

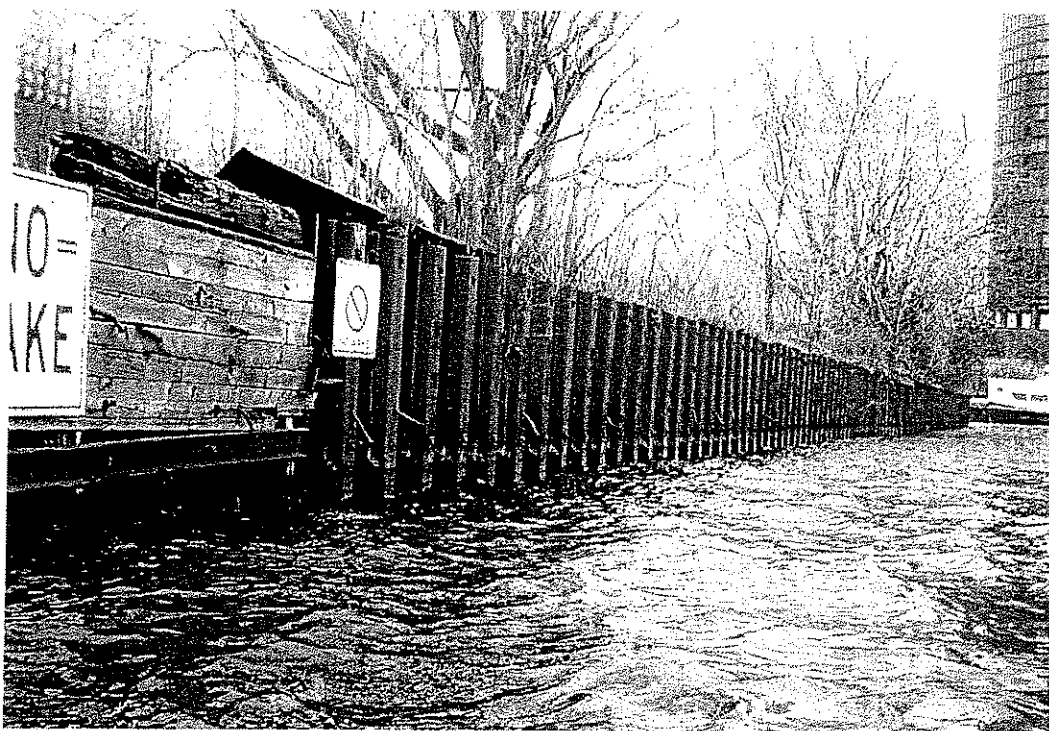
Photograph 2. Overall View of East Dockwall Face, Looking Northwest from Station 3+66.

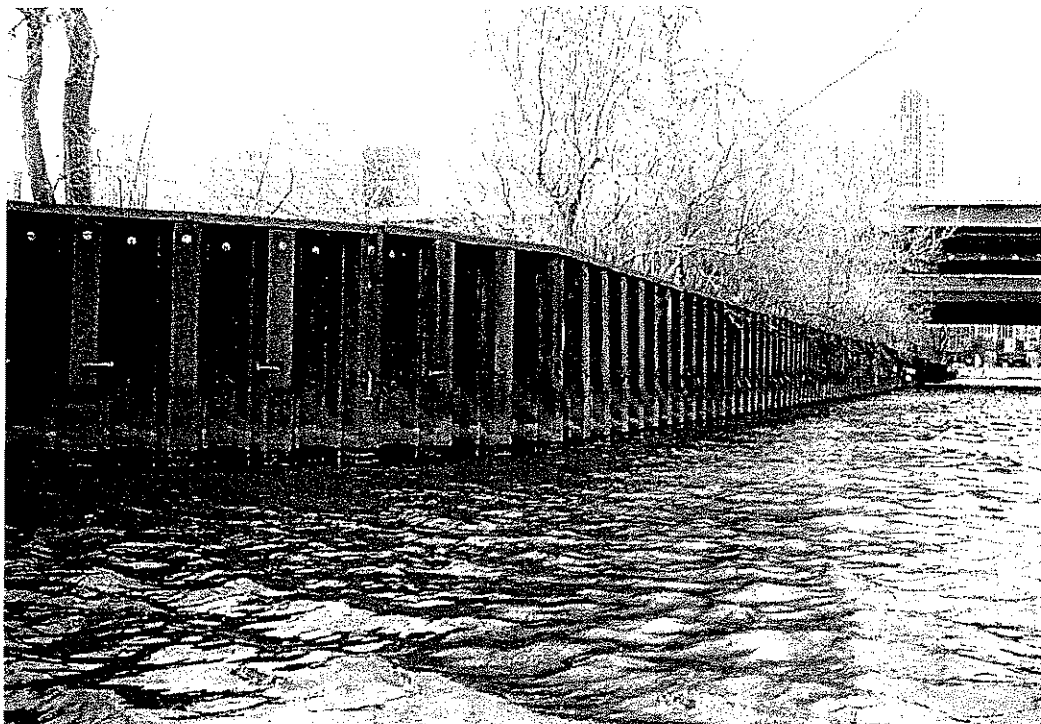
Photograph 3. Overall View of North Dockwall Face, Looking Southwest from Station 7+77.

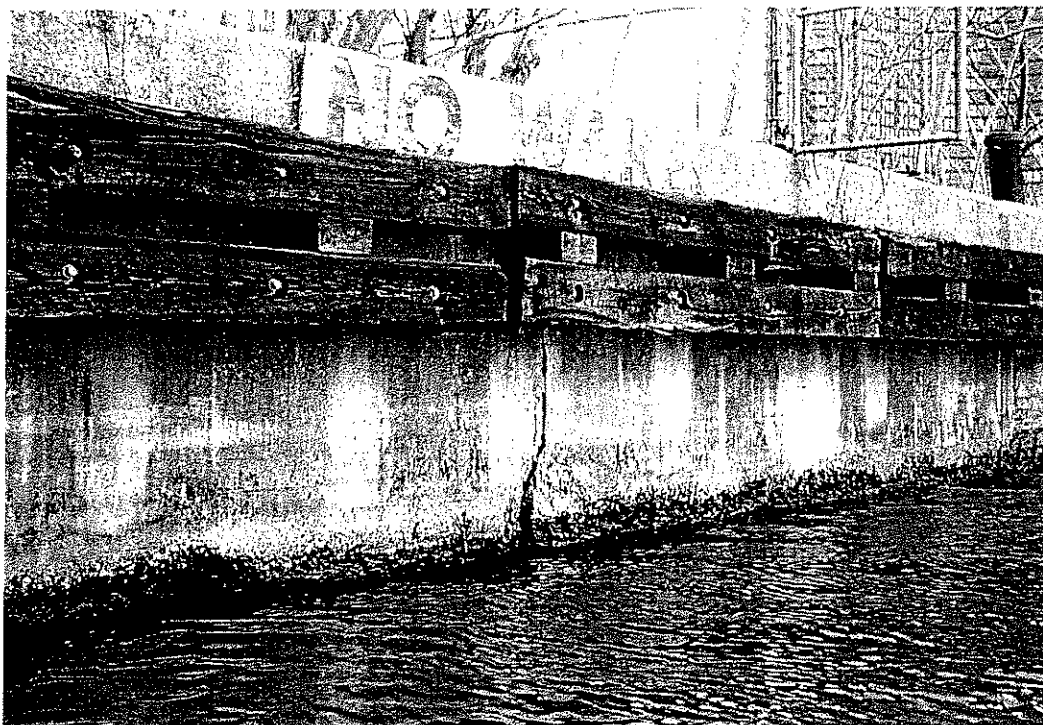
The dockwall in this area consisted of timber Wakefield sheeting with a concrete cap. Timber piles, measuring approximately 12 inches in diameter, were located approximately 1 foot in front of the timber sheeting. The outer layer of timber sheeting was in satisfactory condition with 1/8-inch awl penetrations and random 2-inch wide gaps between sheets. Interior timber piles filled in the gaps at all observed locations. Above water, the concrete cap was typically in fair condition with heavy concrete scale along the bottom corner, having up to 4 inches of penetration. This scale extended 18 inches along the vertical cap face and 12 inches along the cap underside. Random reinforcement was observed in this area, having up to 15 percent loss of section. The protective timber fender was in satisfactory condition with light weathering and random 1/2-inch wide checking. Below water, there was a 1-inch thick layer of marine and aquatic growth extending from the waterline to the channel bottom. Refer to Photographs 4 and 5 in Appendix B for views of the dockwall in this area.

Photograph 4. Dockwall at Station 0+30, Looking Northeast.

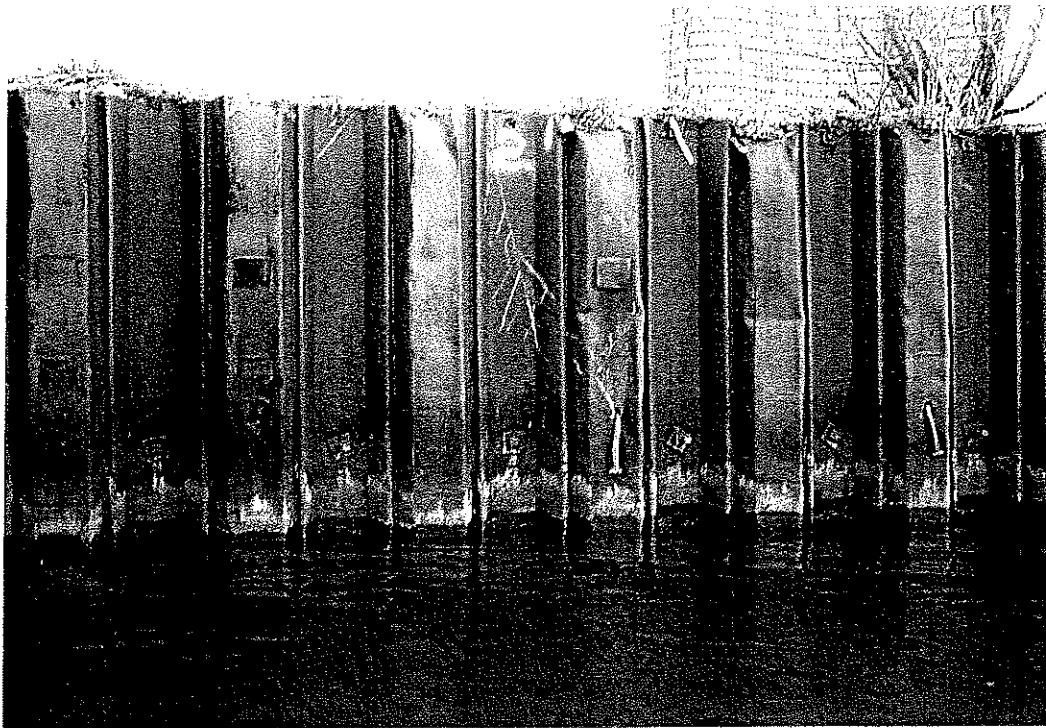
The dockwall in this area was constructed of steel sheeting. Below water, the steel sheeting typically exhibited random rust nodules measuring up to 1 inch in diameter and 1/32-inch deep pitting over 25 percent of the steel surface area. A 1/16-inch thick layer of scale was also located on the sheeting surfaces below water. Heavier scale and pitting, measuring up to 1/8-inch deep, was located from the waterline down 2 feet with up to 10 percent loss of section. The timber fenders were typically missing and the remaining fender anchors were either deformed or missing. Heavy impact damage was observed from Station 2+63 to Station 2+80, extending from 1 foot below the waterline to the top of the wall. All interlocks were intact, except for one location at Station 2+67. This interlock had up to 1 inch of separation from 3 feet below the top of the sheeting to the waterline. In addition, a 1-inch thick layer of marine and aquatic growth extended from the waterline to the channel bottom. Refer to Photographs 6 through 10 in Appendix B for views of the dockwall in this area.

Photograph 7. View of Dockwall at Station 2+00, Looking North.

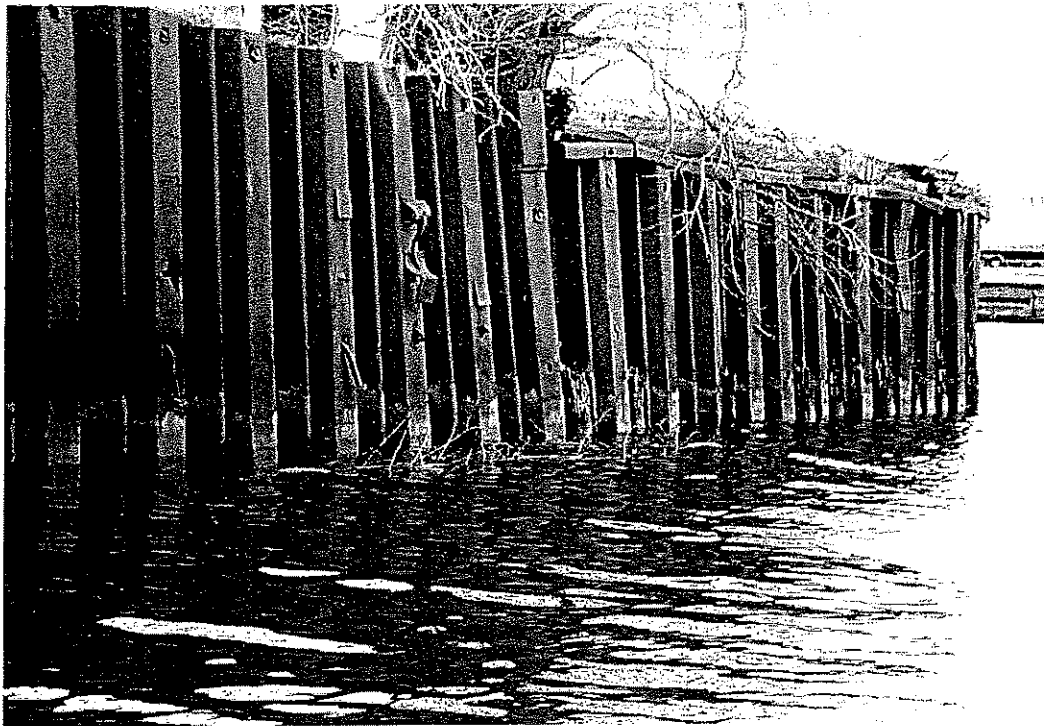
Photograph 9. View of Typical Dockwall Configuration, Looking Northeast from Station 3+00.

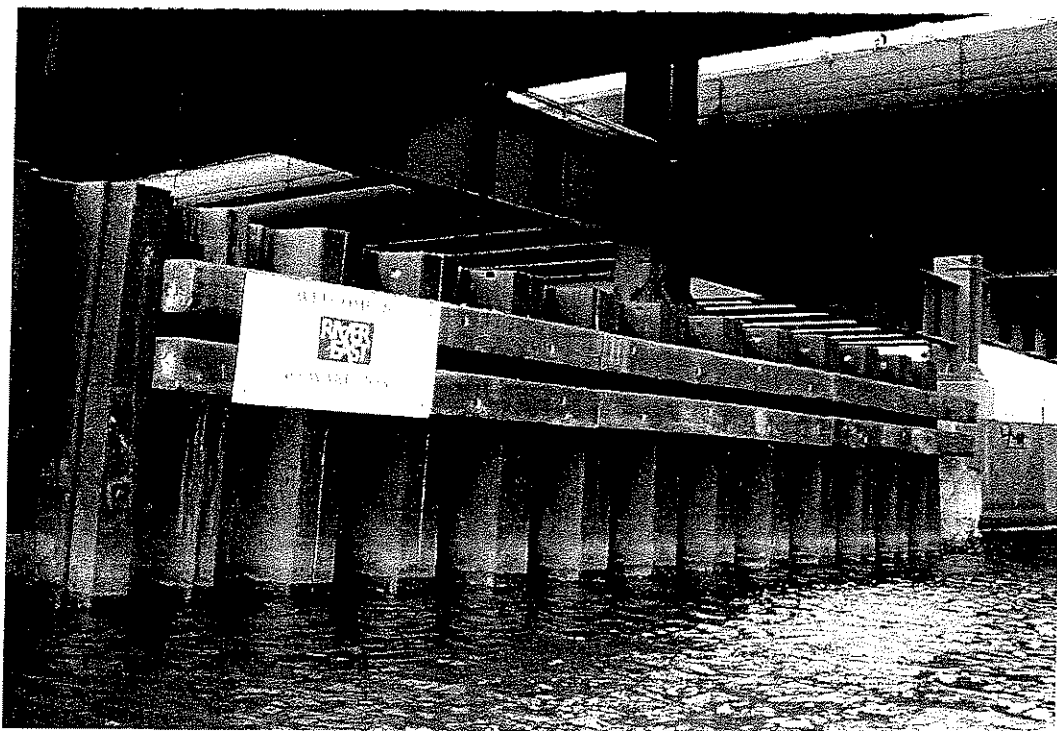
The dockwall in this area was constructed of steel sheeting. Below water, the steel sheeting typically exhibited random rust nodules measuring up to 1 inch in diameter and 1/32-inch deep pitting over 25 percent of the steel surface area. A 1/16-inch thick layer of scale was also located on the sheeting surfaces below water. Heavier scale and pitting, measuring up to 1/8-inch deep, was located from the waterline down 2 feet with up to 10 percent loss of section. Above water, the anchor washers typically exhibited up to 10 percent section loss. All interlocks were intact, with a 1-inch thick layer of marine and aquatic growth extending from the waterline to the channel bottom. Refer to Photograph 18 for a view of the dockwall in this area.

Photograph 18. View of Typical Dockwall Configuration, Looking Southwest from Station 10+85.
